ENVIRONMENTAL ASSESSMENT REPORT

Proposed Piggery

**553 Dick Knobels Rd
MUNYABLA NSW 2658**

August 2018

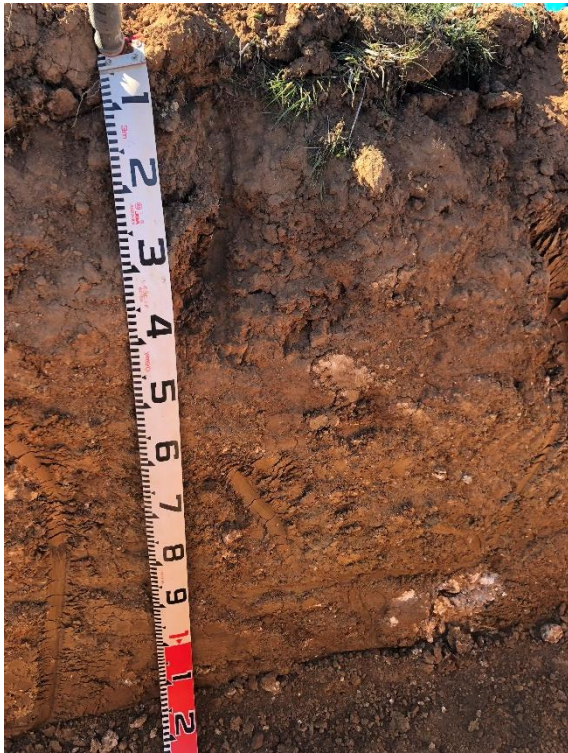
The soil is moderately deep, friable in the topsoil and becoming harder with depth, porous and non-cracking that is currently well-drained and aerated. Field tests showed that the soils do not swell or disperse, but the subsoils are generally low in organic matter. In general, a combination of soil depth, slope, low salinity, open porosity, fine friable subsoil structure, physically unrestricted roots and water penetration, large water holding capacity, moderate drainage, aeration, water and heat transmission, workability and trafficability, are some of the many advantages of these soils. These favourable properties make them suitable for the intended use. Soil pit log sheets can be seen in the **Attachments**.

Figure 3: Typical profile with A and B horizons

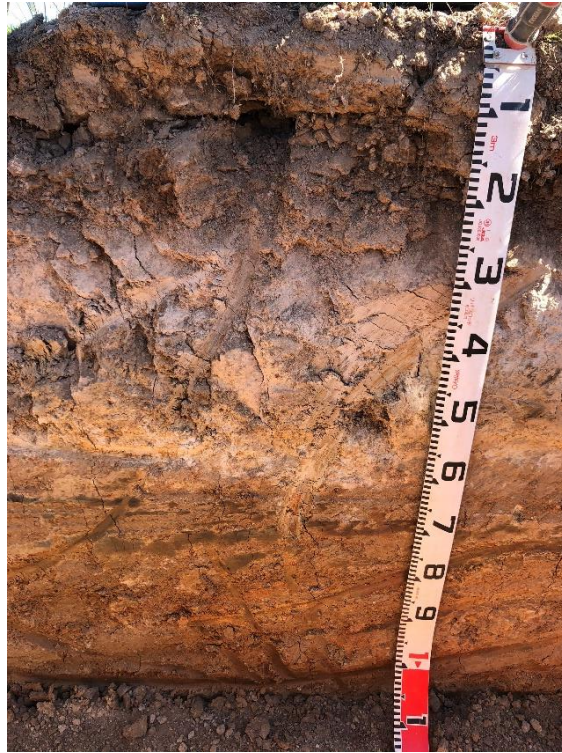
Figure 2: Soil profile with bleached elluvial A2 horizon

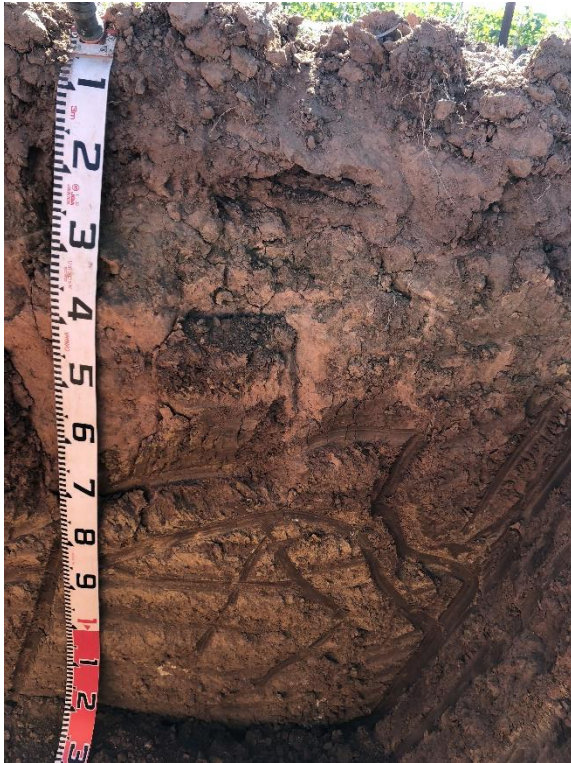
The soil is moderately deep, friable in the topsoil and becoming harder with depth, porous and non-cracking that is currently well-drained and aerated. Field tests showed that the soils do not swell and the topsoils do not disperse, but the subsoils are generally low in organic matter and dispersion testing indicated they may be sodic. In general, a combination of soil depth, slope, low salinity, porosity, fine friable subsoil structure, physically unrestricted roots and water penetration, moderate water holding capacity, fair drainage, aeration, water and heat transmission, workability and trafficability, are some of the many advantages of these soils. These favourable properties make them suitable for the intended use. Soil pit log sheets can be seen in the **Attachments**.

Figure 5: Typical soil profile with A and B horizon

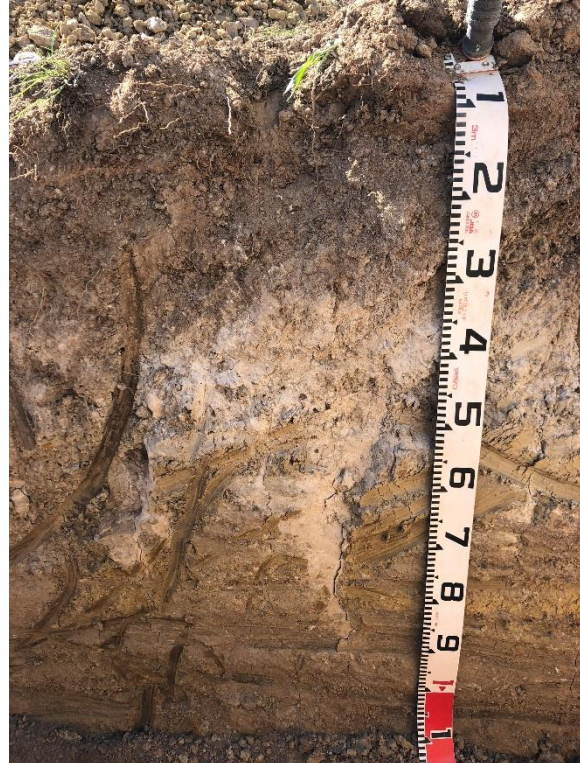
Figure 4: Soil profile with bleached elluvial A2 horizon
